TECHNICAL REPORT NO. 70-5

DEVELOPMENT OF LP WAVE DISCRIMINATION
CAPABILITY USING LP STRAIN INSTRUMENTS
Quarterly Report No. 6, Project VT/8706

TELEDYNE GEOTECH
3401 Shiloh Road
Garland, Texas

30 January 1970

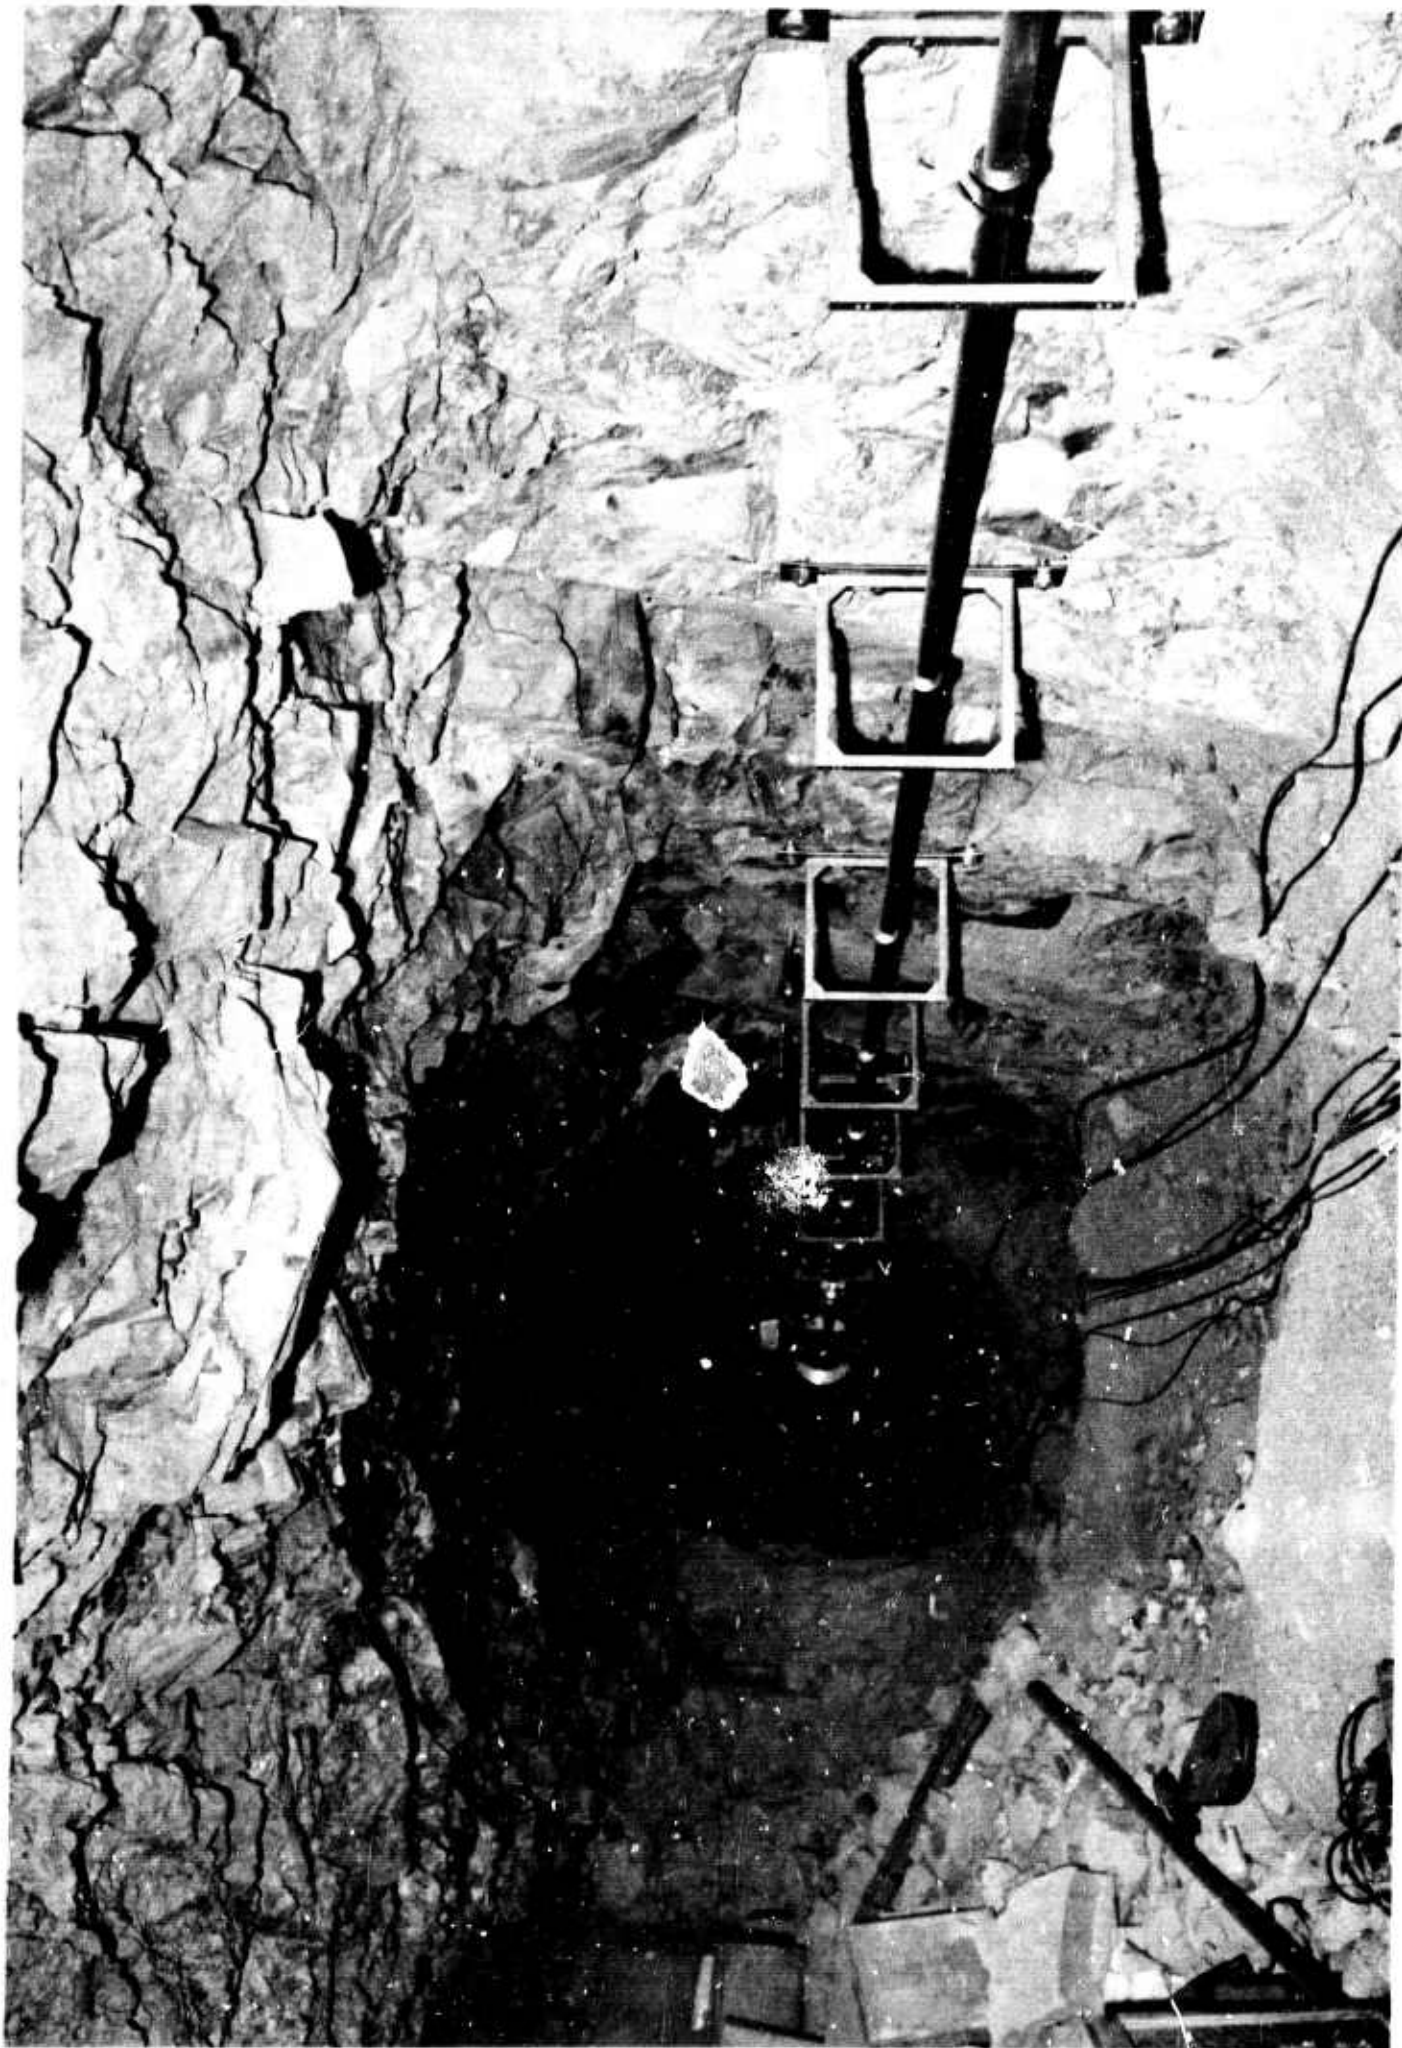
Figure 8. Southwest end of 55 degree horizontal strain seismometer.

The 55 deg azimuth horizontal strain seismometer has been assembled. The southwest end is shown in figure 8. The 2-inch (5.08 cm) outside diameter tube Invar strain rod is supported by a three-wire suspension. Elinvar wire was selected for the suspension because of its small temperature coefficient of Young's Modulus. The Elinvar wire is suspended from a square Invar frame. The frame is square to maintain vertical symmetry so that any temperature changes in vertically-stratified air will be uniform on both sides. The square Invar frame is bolted to an Invar adjustment plate that is bolted to two steel expansion bolts in the rock. The strain rod is supported every 5 or 6 feet to raise any spurious modes of vibration above the frequency range of interest. Figure 9 is a close-up of the velocity transducer and the Ithaco preamplifier. Figure 10 is the strain rod fixed anchor. A fourth expansion bolt will be added to the near lower corner of this anchor. Note the competence of the rock at both end points in figures 9 and 10. Also, note the effectiveness of the controlled blasting technique.

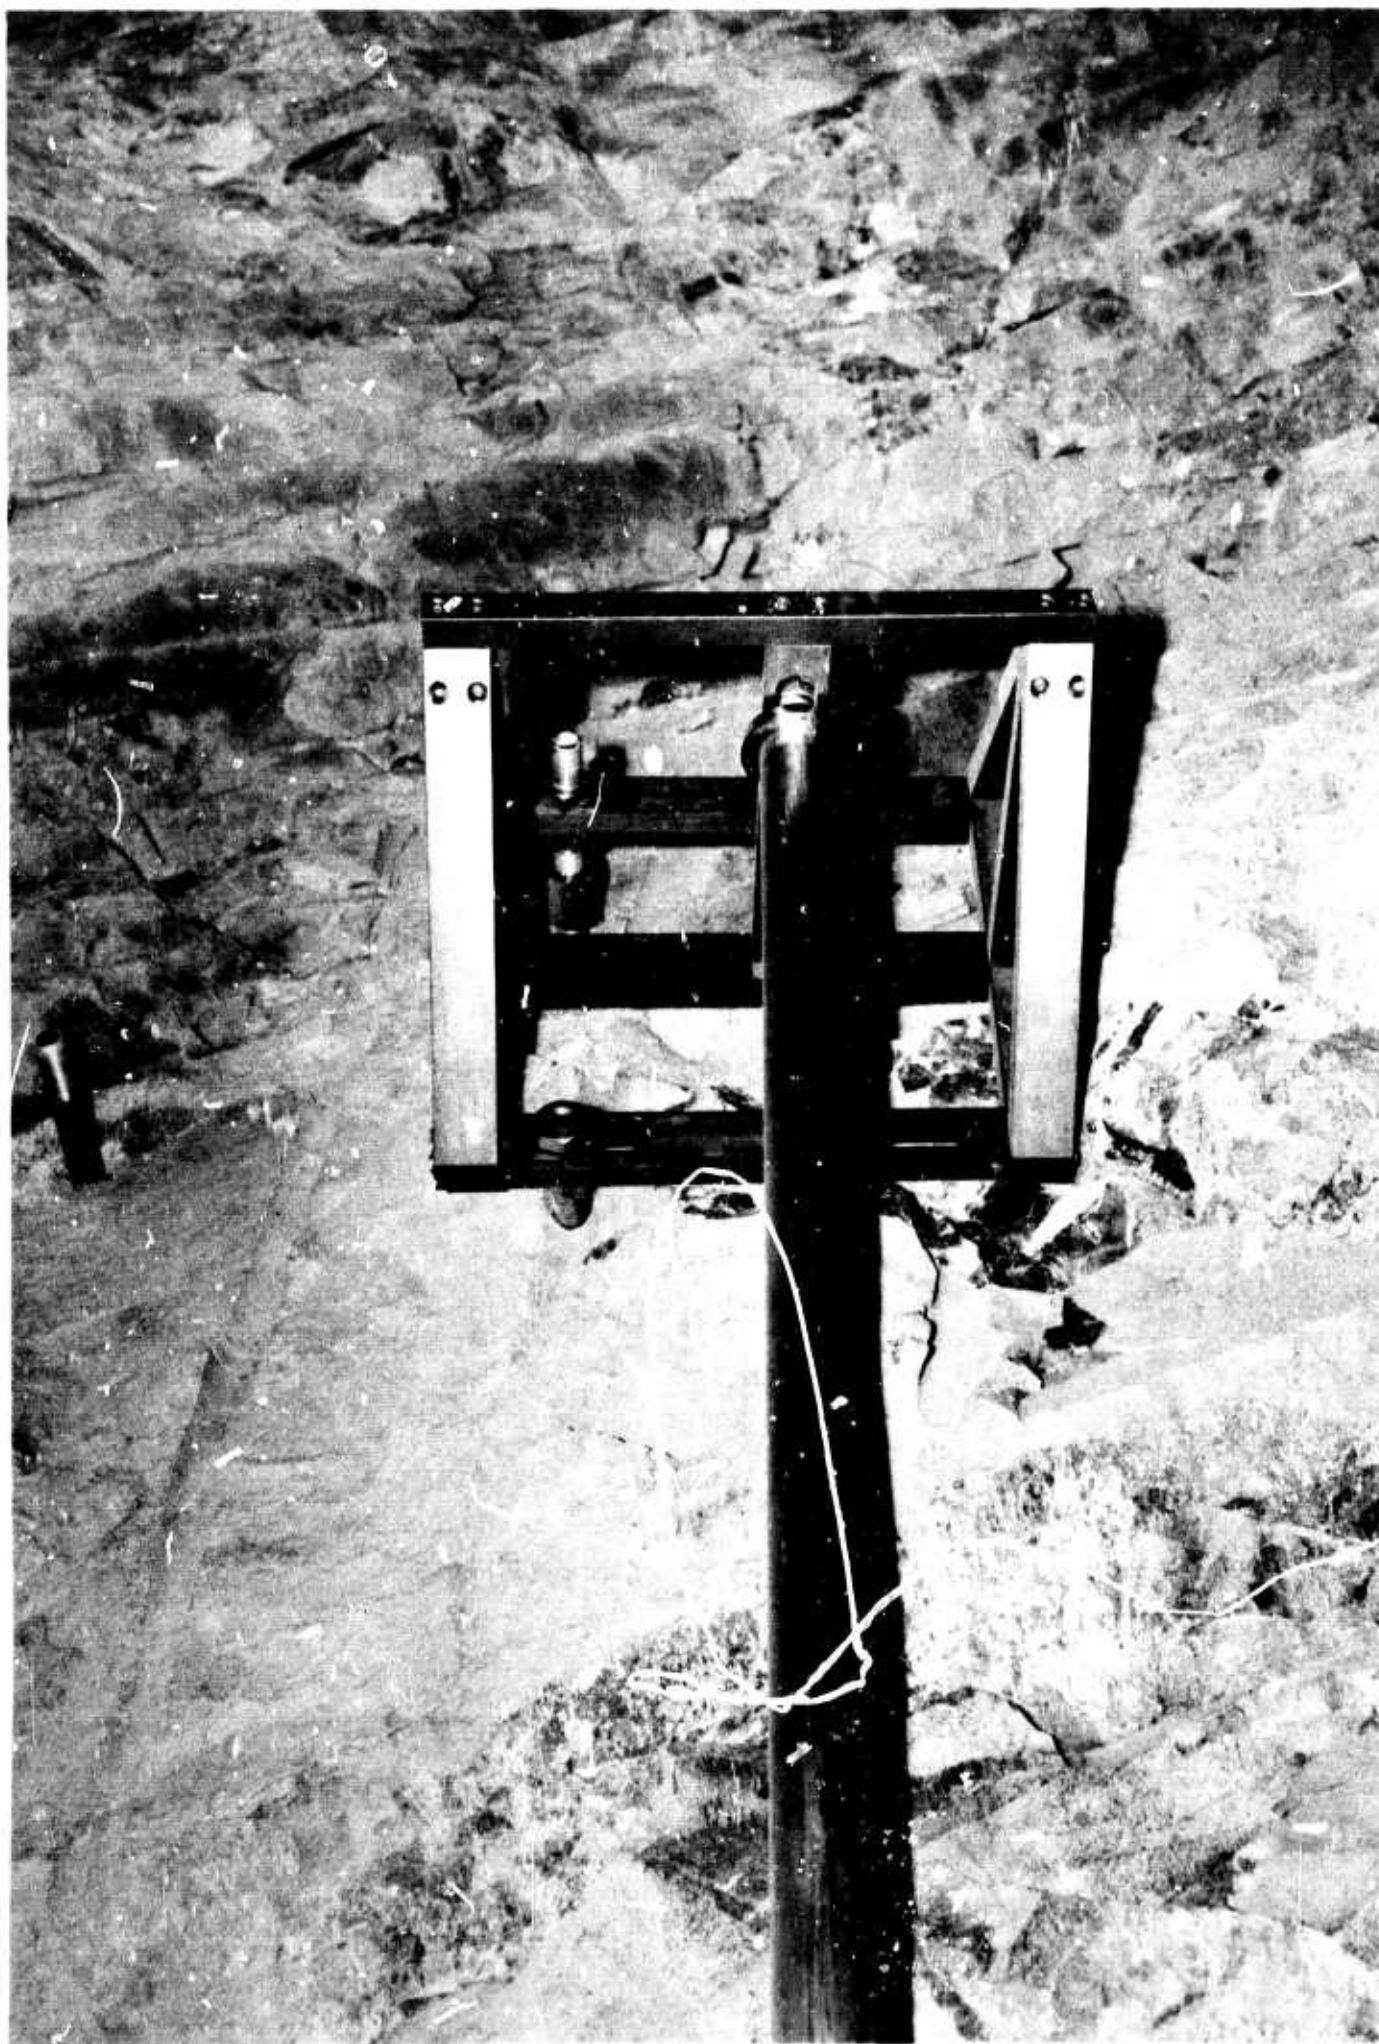
Figure 10. Strain rod anchor.

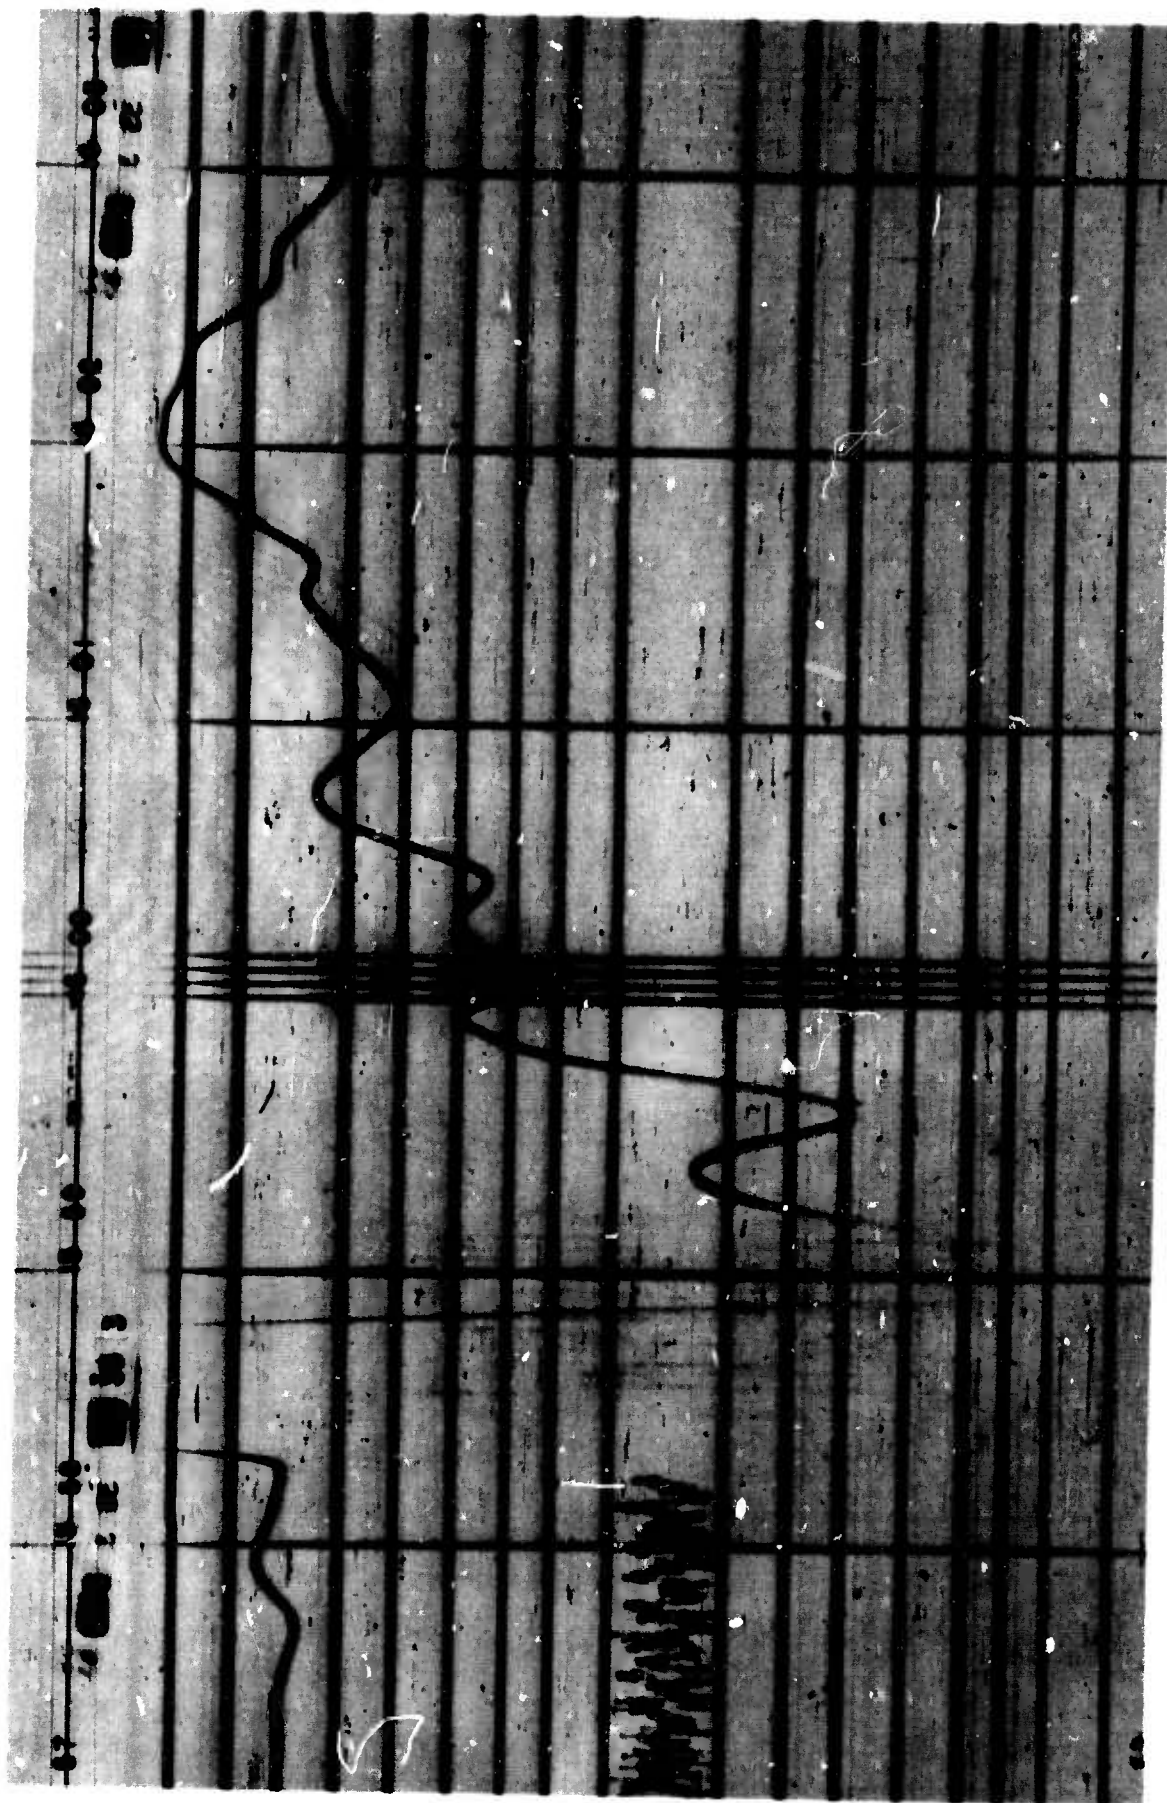
Figure 12. Reproduction of a 16-mm film record showing effect of 4 kg rock hitting strain seismometer support frame.

On 29 November 1969, about a 4 kg rock sloughed off the wall of the mine and hit a support frame on the 55 deg azimuth strain seismometer. The rock is shown in figure 11 being held in the location from which it fell. Figure 12 shows the recording on the S55L and S55S channels when the rock hit the frame. The system rang for about 16 minutes as illustrated in figure 13. For some time before the rock fell the stress relief and strain relaxation could be observed. Figure 14 shows a sequence of four pulses of strain. The pulses are all the same polarity and about the same amplitude. The fine character of the pulse on the SP S55S trace is not completely visible in this recording although a spike can be seen. The character on the LP S55L trace is clearly defined. After the rock fell and the mine and the seismometer again reached equilibrium, the pulses not associated with seismic arrivals almost ceased.
